## REPORT No. 118 ON THE Chelsea Conflagration OF APRIL 12, 1908

# The Chelsea Conflagration

of April 12, 1908

Report by Winthrop P. Tenney, Benjamin Richards, John W.  
Chapman and Gorham Dana

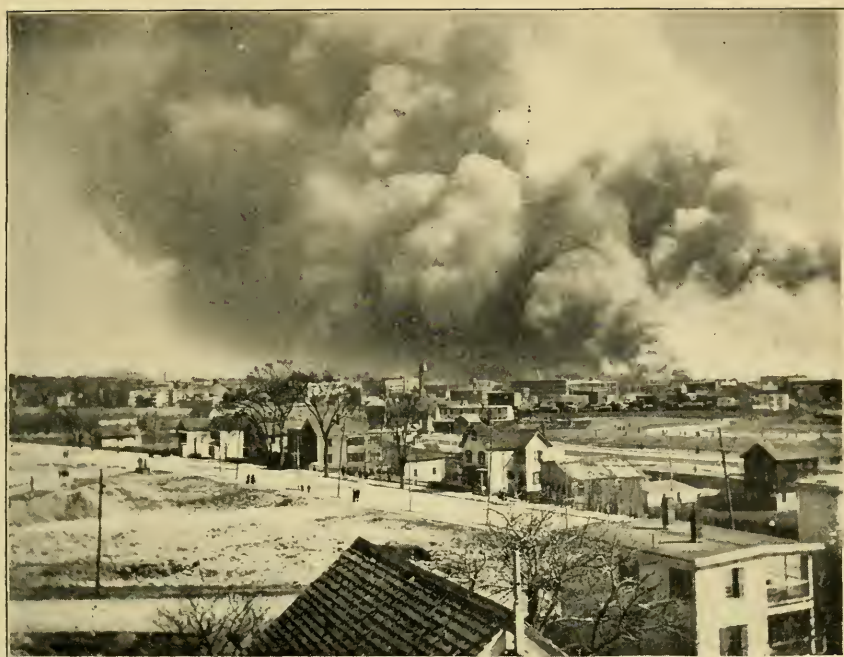
Fig. 1. General view of conflagration from the northwest, about 11.30 A. M.

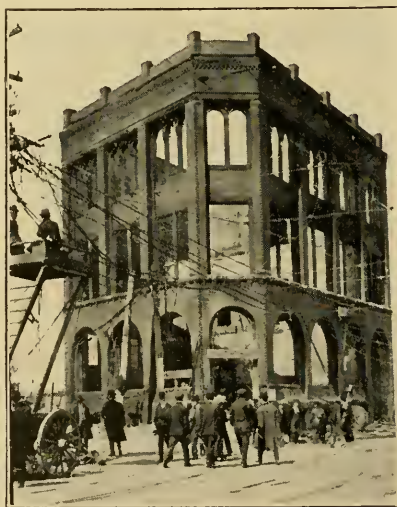
Fig. 2. The Chelsea Trust Co. building

There were no fire resisting buildings throughout the burned area. The nearest approach to this seen was the building occupied by the Chelsea Trust Co. While not in any sense fire resisting, its walls were very nearly blank toward the conflagration and the bricks well laid and bonded. This building received a heavy part of the conflagration and although the interior was completely burned, the walls successfully withstood the flames, doubtless serving to some extent to prevent further progress of the fire to the southeast.

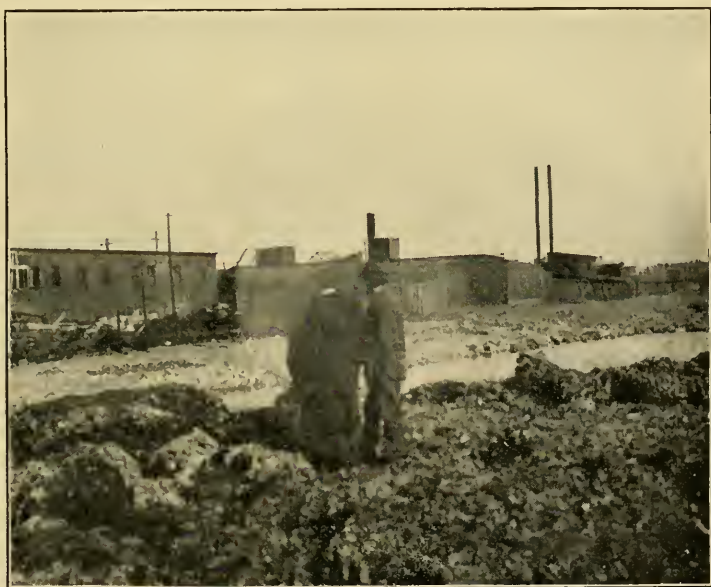
Fig. 3. Rag pile where fire started, in foreground Boston Blacking Co. buildings at left, Hecla Compress Gas Co. on right. Looking east

The ignition of rags and waste in the rear of Second Street near the corner of Carter Street first started the fire. This section of the town at the extreme west was mostly open wet land in process of filling. The usual dumps and numerous rag shops were in evidence. There were great piles of cotton and yarn waste, also woolen rags spread over the ground to dry. In some way unknown, these were ignited, causing a smouldering fire which had probably been burning some time. The wind, which was very high, was unusually severe in this locality owing to the open stretch of flat country extending over the marshes toward Everett. The burning rags were blown against the "McKay" wax shop of the Boston Blacking Co. about two hundred feet distant, and set fire to it. Rags drying in the vacant space east of the Hecla Compress Gas Co.'s buildings next took fire and ten or fifteen minutes later the fire broke out in a large pile of rags inside Lewitsky's rag yard about nine hundred feet to the southeast of the blacking factory. It was at Lewitsky's and Rosenfield's rag shops adjoining each other on Third, Elm and Maple Streets, that the conflagration really started.

The fires in the Boston Blacking Co.'s building and in the vacant space east of the Hecla Compressed Gas Co.'s factory undoubtedly were due to rags or sparks from the original fire but there is some doubt as to whether the fire in Lewitsky's yard and building can be attributed to this cause. Incendiarism is openly charged and there are too many of these reports to doubt that in part they have some real foundation. The State Police are now investigating the matter. Burning rags may have been blown by the wind to Lewitsky's yard, if so, they must have passed over an enclosure containing tar paper storage and a two-story frame laundry on Maple Street.

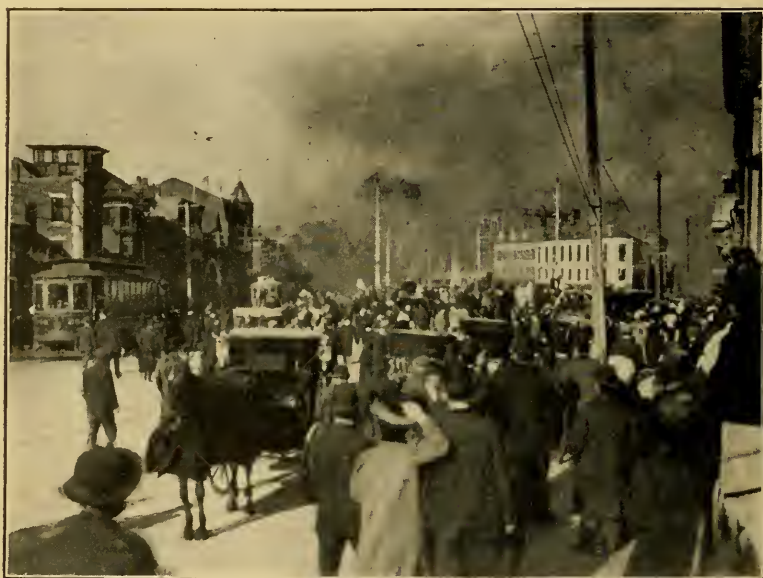
Fig. 4. View across Broadway Sq. about 4 P. M. during fire

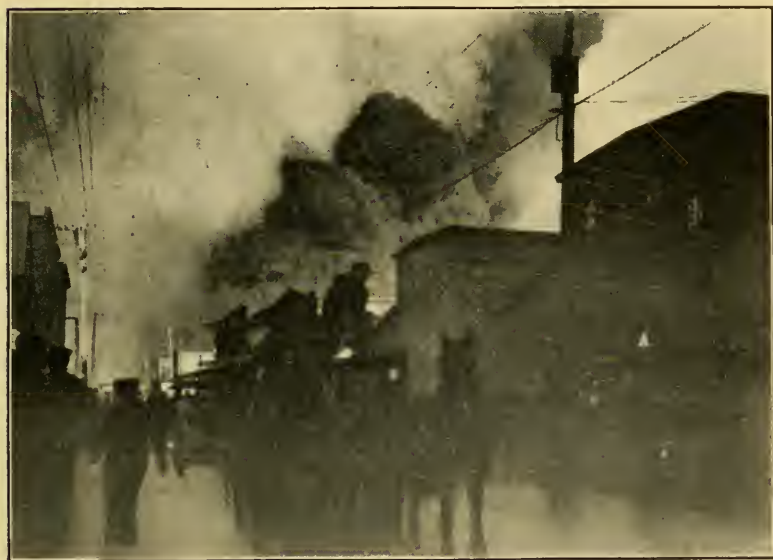
Fig. 5. View in Marginal St. opposite Magee Furnace Co. showing smoke from oil plants

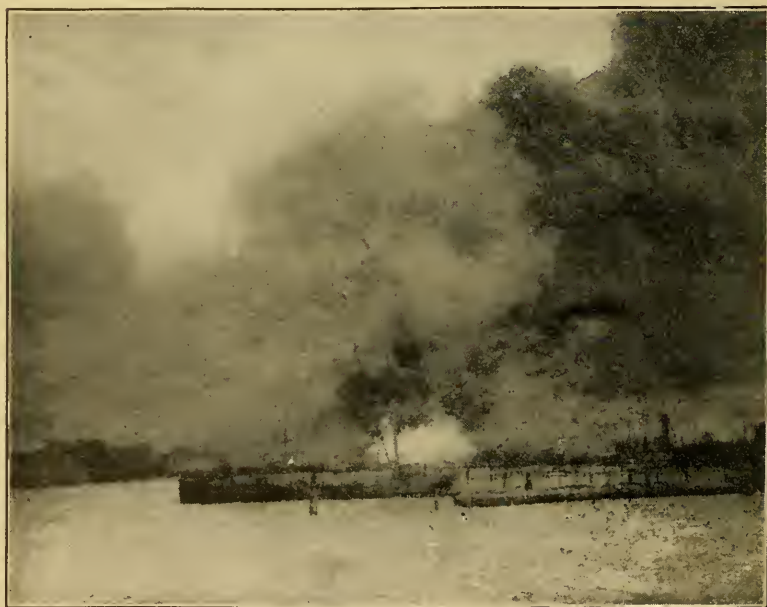
Fig. 6. View from Meridian St. Bridge, looking east, about 6 P. M.

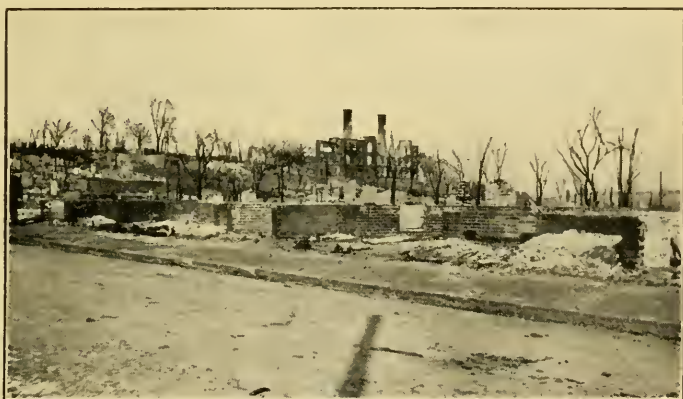
Fig. 7. General view of Bellingham Hill showing ruins of Highland School

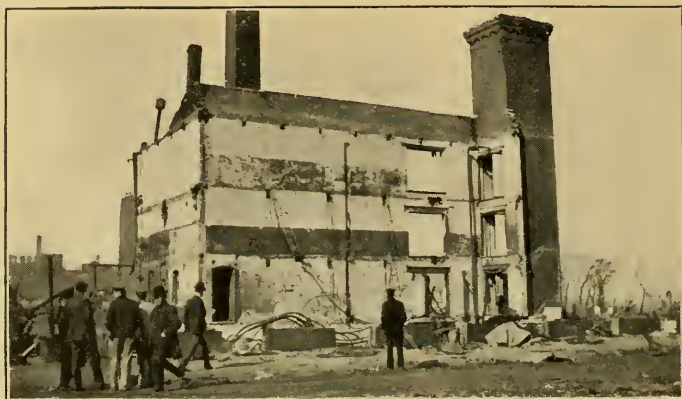
Fig. 9. Ruins of American Circular Loom Plant, from the south.  
Sprinkler tank was on top of brick tower

THE AMERICAN CIRCULAR LOOM CO. was located at the corner of Suffolk Street and Highland Avenue on the southeasterly edge of the burned area. The main building was three stories, about ninety by ninety. About one-third was brick with plank and timber floors and roofs, the remainder being wood open joist construction and having a Mansard roof with attic. There was also a two-story brick machine shop and storehouse about one hundred and twenty by forty, located thirty-five feet north of main shop. This latter building had no sprinklers. The main building was equipped with Grinnell Glass Disc sprinklers supplied by six-inch pipe from six-inch city main and a ten thousand gallon gravity tank on brick tower, bottom twelve feet above sprinklers. There was an alarm valve and standard watchman's

service. The exposure was light in the rear but across the street on the side from which the conflagration approached, there was a three-story wood tenement block, a three-story wood curry shop and also various wood dwellings and sheds. The curry shop became ignited from sparks before 1 o'clock, much in advance of the main line of fire, and burned rapidly setting fire to the tenement block which in turn ignited the Circular Loom Co. Fire first caught on the sprinkler tank house and wood cornices and worked into main roof. Several employees fought the fire with chemicals and small hose but without effect. Sprinklers opened properly but the tank was quickly drained and city pressure at that time and place was insufficient to supply the upper lines. No hose streams were available and the risk therefore quickly burned. The unsprinklered building burned afterward. The loss is practically total, the only portions standing being the brick elevator tower and the boiler room.

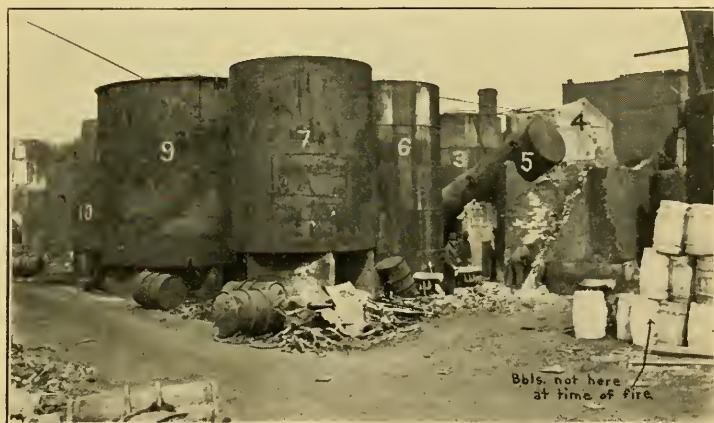
Fig. 10. Westerly group of tanks at plant of Samuel Cabot Co.

SAMUEL CABOT CO.'S lampblack and stain factory furnishes more interesting data than any other building in the district as some effort had been made to protect it against fire. It was completely burned out but practically all the brick walls are standing, showing good construction. Many of the roofs were of hollow tile, supported

by steel beams spaced one foot on centre but unprotected. Where there was heavy fire, the roofs fell owing to the collapse of the beams but those buildings in which there was little combustible material stood up well. There were some fair tin covered shutters on part of the buildings. Some of them were completely destroyed but two which were barred closed, stood the test well, although the wood inside the shutters was practically all destroyed. There was also a one-eighth-inch iron door reinforced with strips at the edges. It was badly warped, one corner being at least two feet out of true. The yard contained many tanks of creosote, benzol and coal tar pitch. All the tanks which had wooden covers soon took fire. Some of the benzol tanks had heavy iron roofs with a man-hole cemented closed. The

covers were blown off and the contents burned like a torch. There was no explosion in any case and the tanks are mostly in good condition. There were a large number of full benzol drums in the yard. The sides of these are bulged and cracked, and the contents burned. Some

of the benzol tanks between these drums and two large benzol tanks at the east end of the yard were not burned. Tanks which stood on wharves and bulkheads supported by wooden piles toppled over. Those on concrete and brick piers remained in position. The concrete piers withstood the heat with little damage. Photograph shows the west group of tanks as they appeared after the fire. The numbers correspond to the numbers on ground plan and tables. Further data in regard to the tanks is given in the following tables.

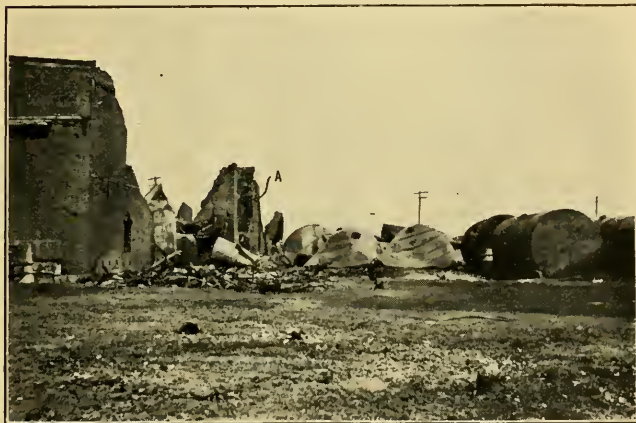
Fig. 12. View of Valvoline Oil Co. Plant, showing remains of tanks and position of wall "A"

THE VALVOLINE OIL CO. was the worst damaged of any of the oil works. There were several buildings, partly brick and wood covering the oil tanks, in which was stored naphtha, kerosene oil and various machine oils in large quantities. Many of these tanks had no covers and the contents easily ignited as soon as the buildings were on fire. The naphtha was in covered horizontal tanks. Very soon these exploded and great havoc was created. Half of one of the tanks was hurled a hundred feet away and the remainder of it was forced into a nearby tank crumpling it up like so much tissue paper and throwing the contents all around the yard. The heat was intense. Some of the tanks were melted and many of the bricks on one wall of the building fused.
